Chapter 2

Structural Vulnerability

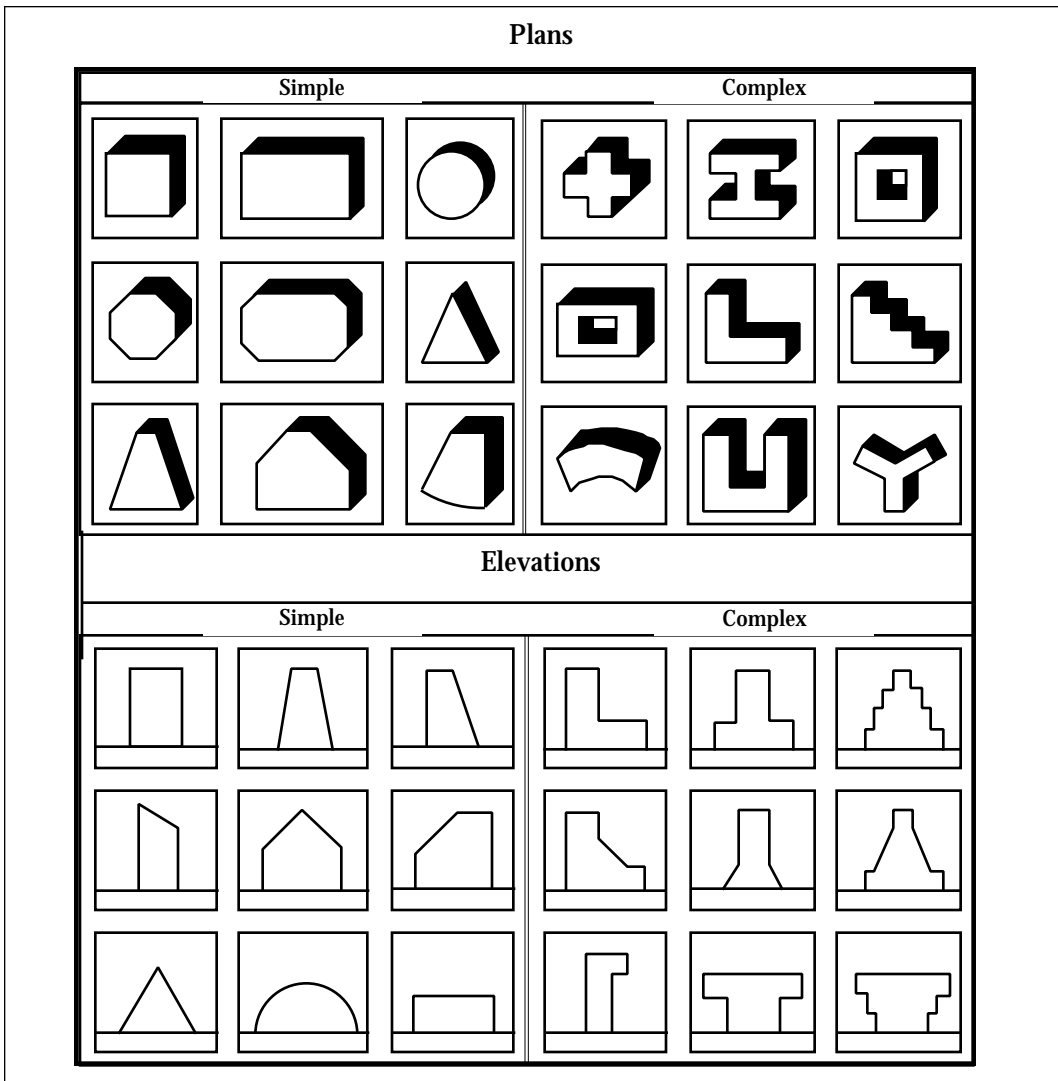
Figure 2.1.
Simple and complex forms in plan and elevation

urations. Generally speaking, it may be said that a departure from simple structural forms and layouts tends to be severely punished by earthquakes. Figure 2.1 illustrates simple and complex configurations. Unfortunately, the usual methods of seismic analysis fail to adequately quantify problems related to configuration. In any case, given the erratic nature of earthquakes, as well as the possibility of their exceeding design levels, it is advisable to avoid hazardous configurations, regardless of the degree of sophistication that may be reached in the analysis of each individual case.²

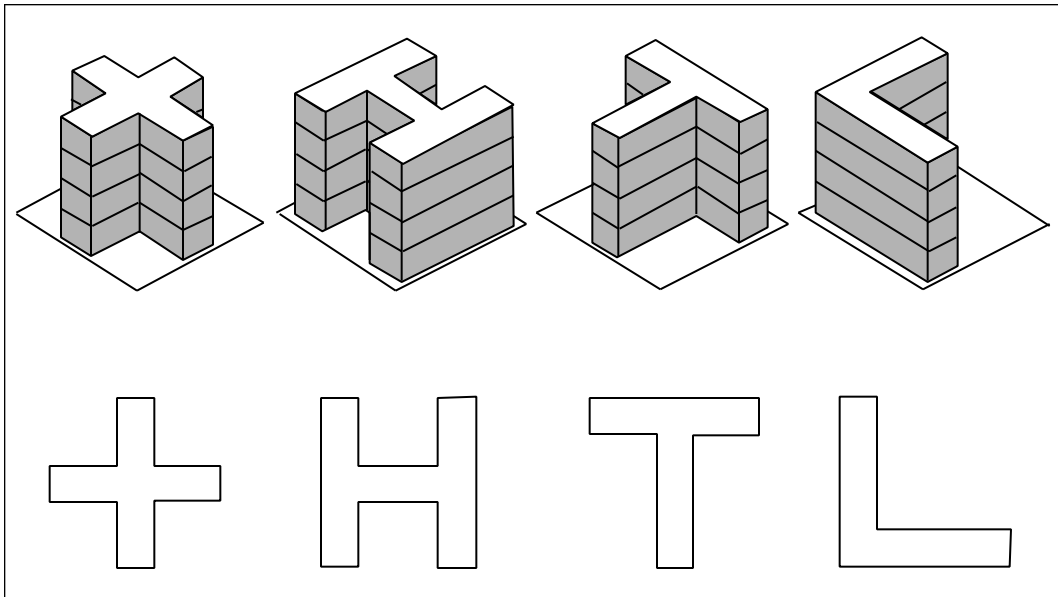
Figure 2.2.
Complex plans

body of the building, a point that would suffer smaller lateral distortions than in the rest of the wing. Large concentrations of stress appear in such transition areas, frequently producing damage to the non-structural elements, the vertical structure, and even the diaphragms (that is, the horizontal resistant elements of a structure such as floors and roofs).

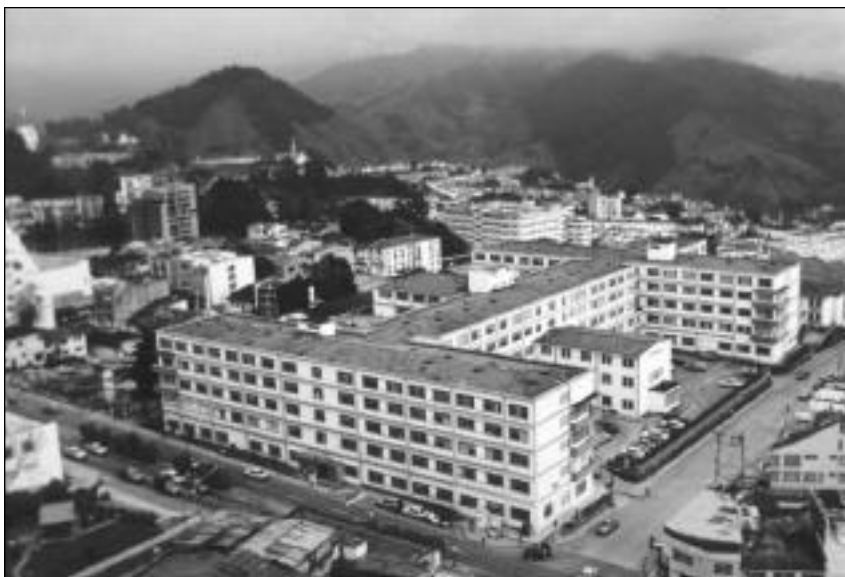
Photograph 7. Caldas Hospital in Colombia

Concentration of stress arises in buildings with complex floor plans, and is very common in hospital buildings. A complex plan is defined as that in which the line joining any two sufficiently distant points lies largely outside of the plan. This occurs when wings of significant size are oriented in different directions, for instance in H, U, or L shapes (see figure 2.2 and photograph 7).

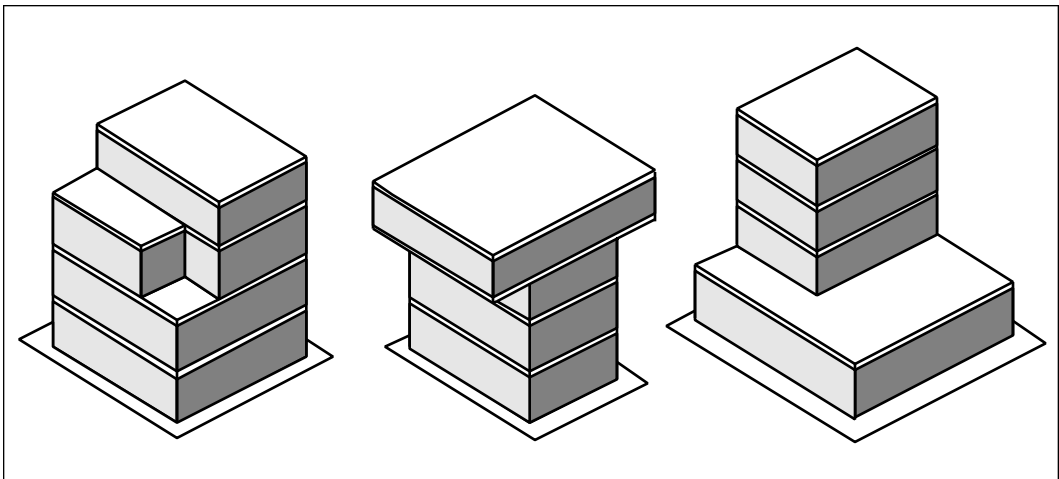
Figure 2.3.
Buildings with irregular vertical shape

Setbacks in the volume of a building usually arise from urban design demands for illumination, proportion, etc. However, in seismic events they are the cause of abrupt changes in stiffness and mass producing a concentration of stresses in the floors near the site of sudden change (figure 2.3). In general terms, one should ensure that the transitions are as gradual as possible in order to avoid such concentration of stresses.

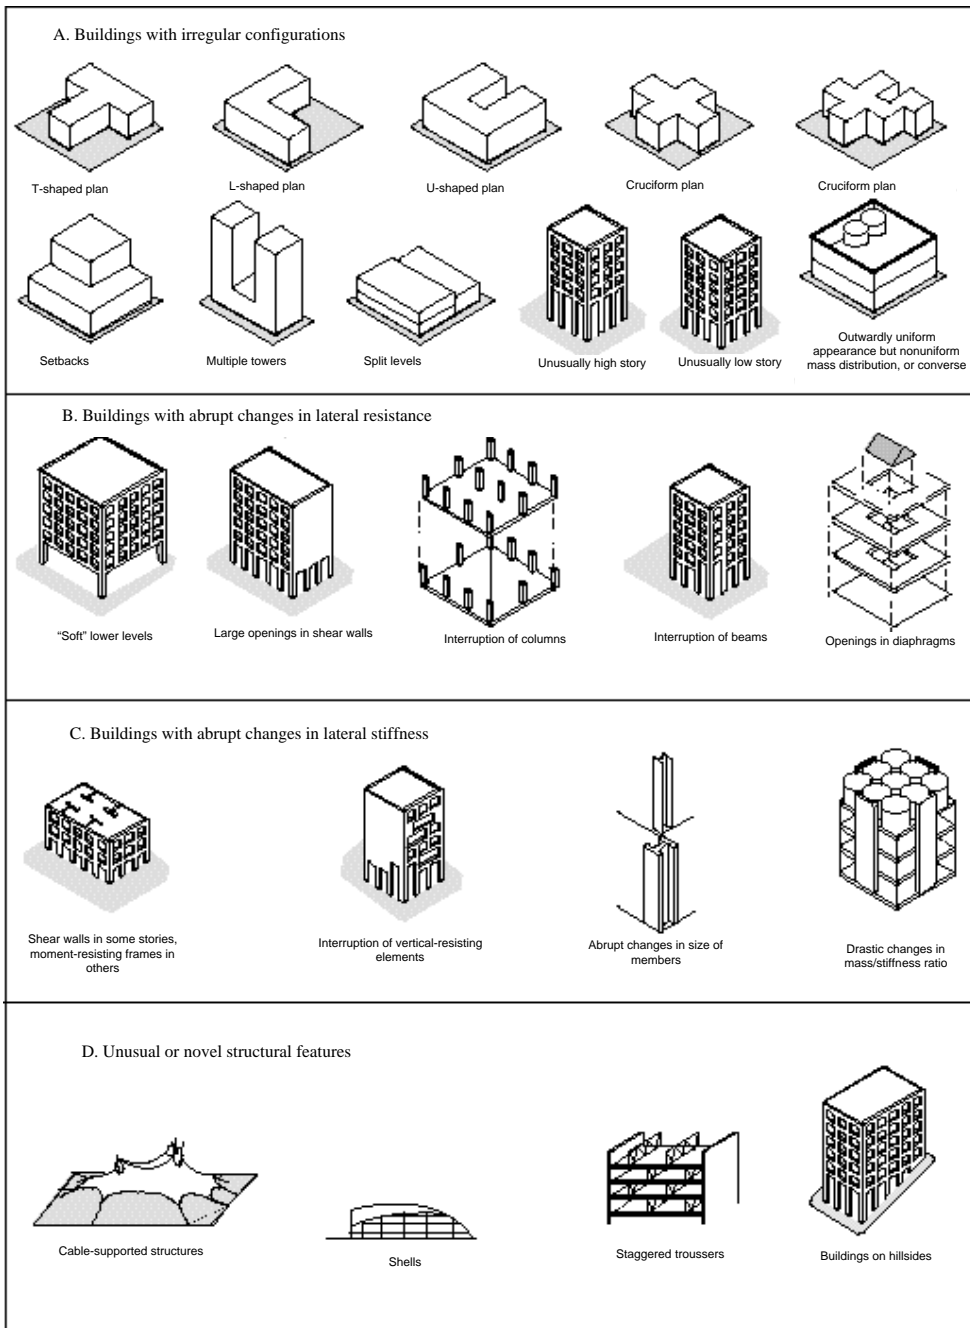
Figure 2.4.
Irregular structures

Figure 2.4 shows some characteristics of building configuration that should be avoided in health facilities, due to their inadequate performance in earthquakes.

Graphic interpretation of irregular structures or framing systems, from the Commentary to the SEAOC Recommended Lateral Stress Requirements and Commentary. Reproduced in Arnold, Christopher and Reitherman, Robert, *Building Configuration and Seismic Design* (John Wiley and Sons, New York: 1982, p. 8). Reproduced with permission.

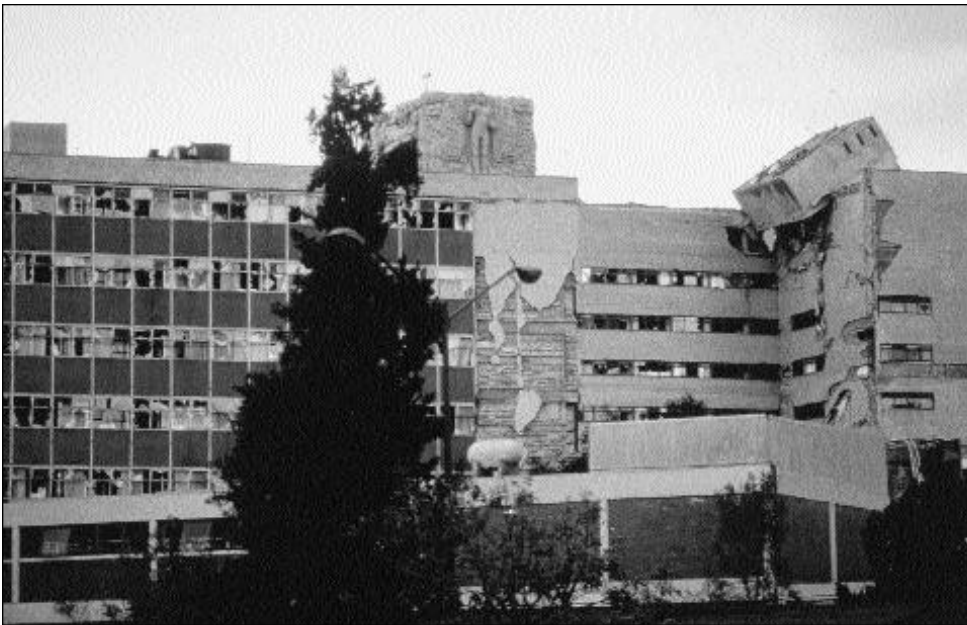
High concentrations of mass on a given level of the building are problematic. This occurs on floors where heavy items are placed, such as equipment, tanks, storerooms, or filing cabinets. The problem is greater the higher the heavy level is located, due to the fact that seismic response accelerations increase upward, increasing seismic forces and the possibility of equipment collapsing and causing structural damage (see photograph 8).

Photograph 8. Concentrations of mass, such as water tanks placed on the roof of a hospital, can cause severe damage in earthquakes.

In architectural design, it is recommended that spaces for unusually heavy weights be in basements or in buildings isolated from the main structure. If elevated water storage is required for topographical reasons, it is preferable to build independent towers instead of attaching towers to the main building.

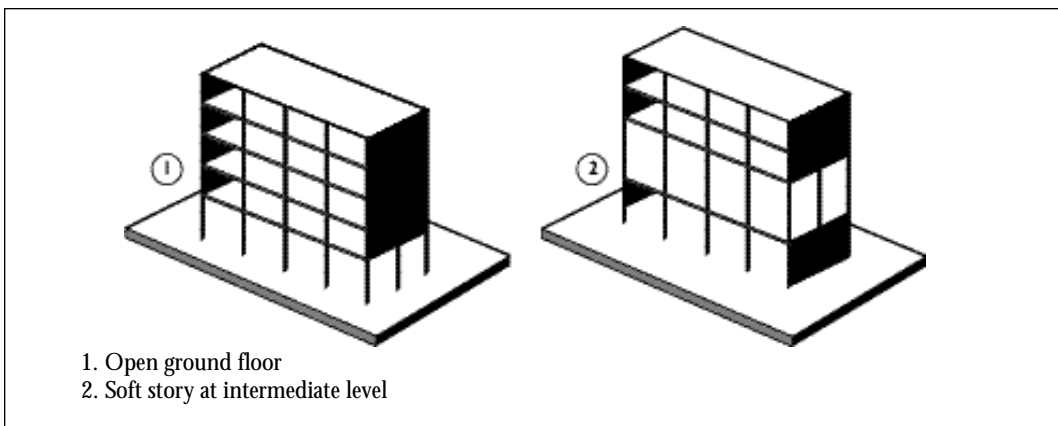
Figure 2.5.
Examples of buildings with "soft story" irregularity.

Several types of architectural and structural plans lead to the formation of so-called "soft" stories, which are stories that are more vulnerable to seismic damage than others due to the fact that they are less stiff, less resistant, or both (see figure 2.5). The presence of soft stories can be attributed to:

- Differences in height between floors;
- Interruption of the vertical structural elements on the floor.

Differences in height between stories arises frequently because of the need for greater space at certain levels of the building, generally for technical (equipment requirements, etc.) or aesthetic reasons (image of the building at the access levels). This results in lessened stiffness of the stories in question, due to the greater height of the vertical elements.

The interruption of vertical elements (walls and columns) of the structure has been the cause of partial or total collapses in buildings subjected to earthquakes, especially when this occurs in the lower floors (see photographs 9–11). The level on which the elements are interrupted is more flexible than the others, which increases the problem of stability, but also because the abrupt change in stiffness causes a greater accumulation of energy on the weaker story. The most common cases of interruption of vertical elements, which occur generally for spatial, formal, or aesthetic reasons, are the following:

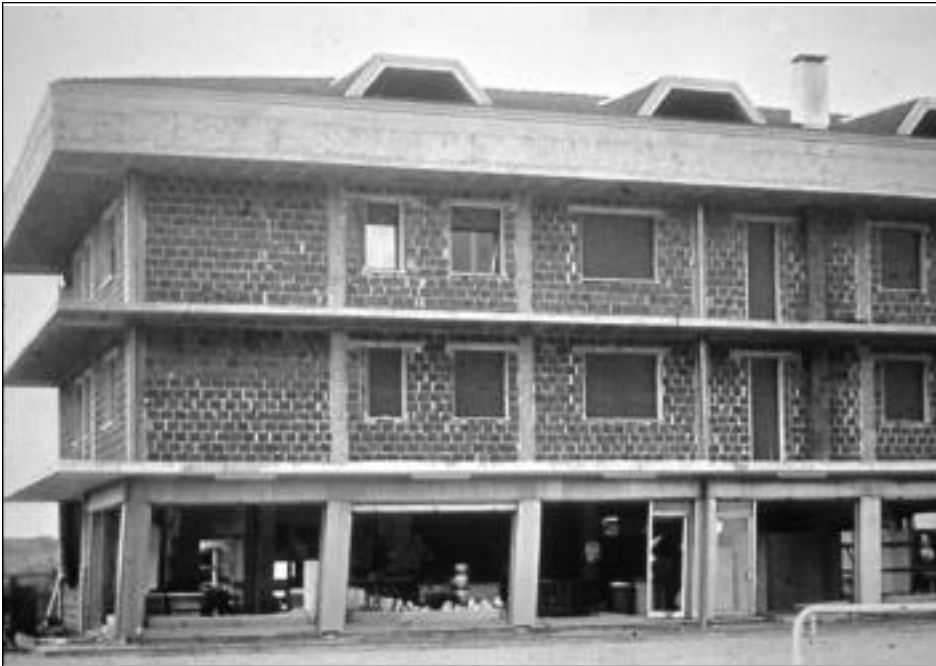
Photograph 9. Failure on ground floor due to soft story.

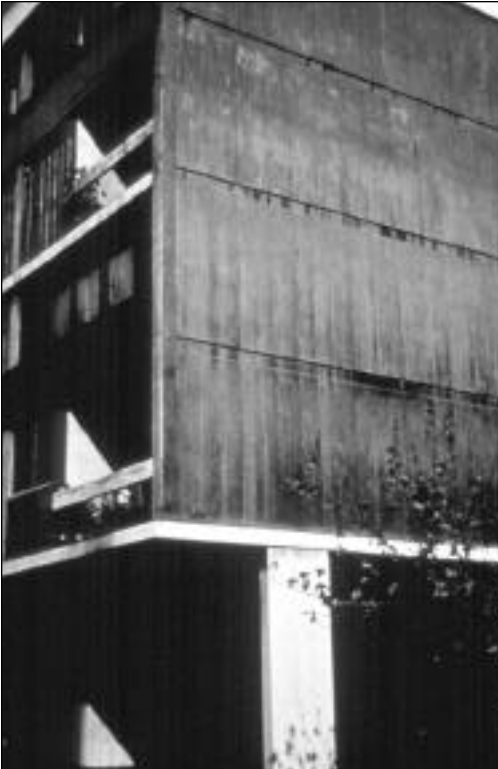
Photograph 10. Interruption of a structural wall on the ground floor

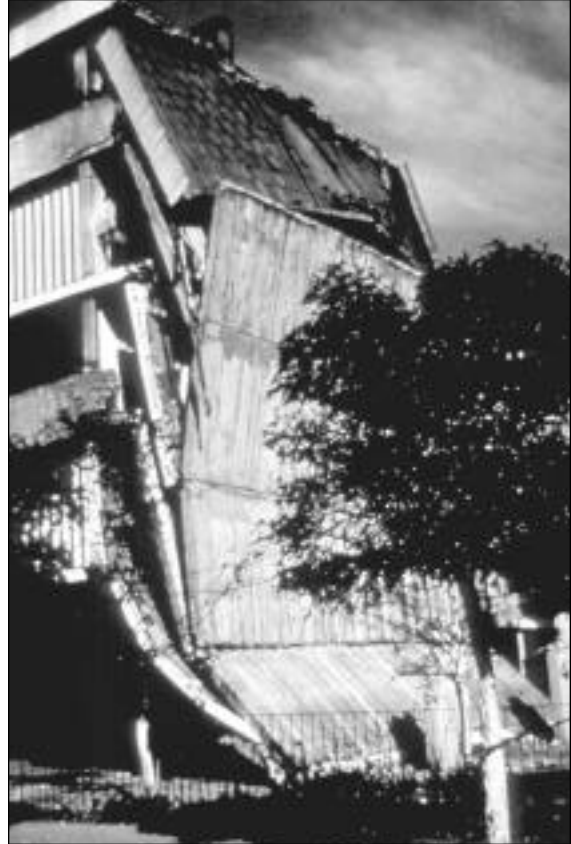
Photograph 11. Structural collapse due to the discontinuity of vertical elements.

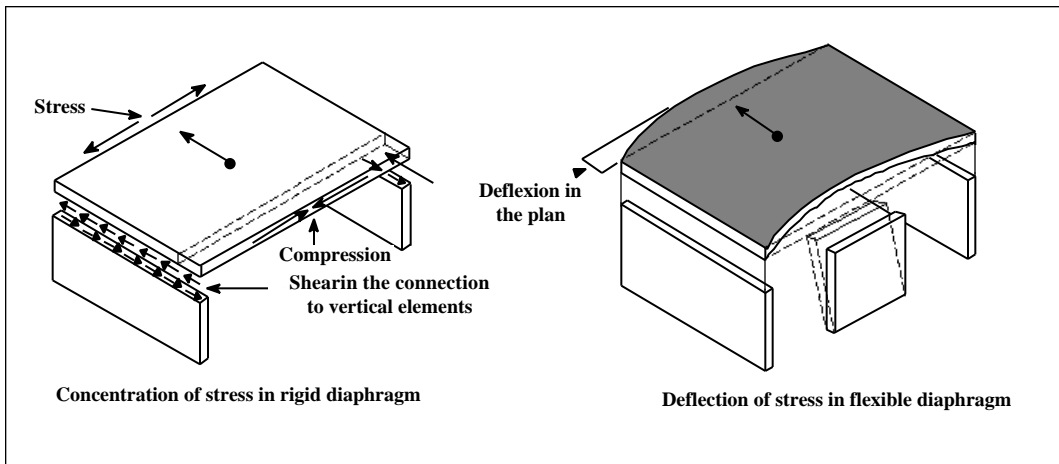
Figure 2.6.
Rigid and flexible behavior of the floor diaphragm

An excessively flexible floor diaphragm involves non-uniform lateral distortions, which are in principle prejudicial to the nonstructural elements attached to the diaphragm. Additionally, the distribution of lateral forces will not be in accordance with the stiffness of the vertical elements (see figure 2.6).

There are several reasons why there can be this type of flexible performance. Among them are the following:

- *Flexibility of the diaphragm material* Among the usual building materials, wood or steel decking without concrete are the most flexible.
- *Aspect ratio* (length/width) of the diaphragm. The greater the length/width ratio of the diaphragm, the greater the lateral distortions may be. In general, diaphragms with aspect ratios greater than 5 may be considered flexible.

- *Openings in the diaphragm* Large openings in the diaphragm for purposes of illumination, ventilation, and visual connections between stories cause flexible areas that impede the rigid assembly of the vertical structures.

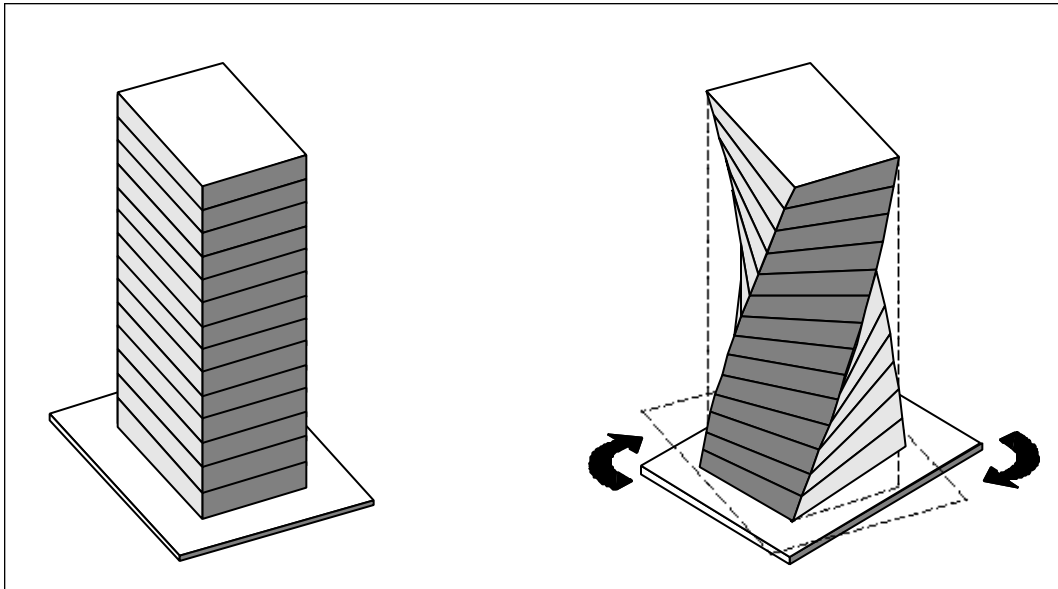
Figure 2.7.
Torsion

Torsion has been the cause of major damage to buildings subjected to strong earthquakes, ranging from visible distortion of the structure (and its resultant loss of image and reliability) to structural collapse (figure 2.7). Torsion is produced by the eccentricity existing between the center of mass and the center of stiffness. Some of the situations that can give rise to this situation in the building plan are:

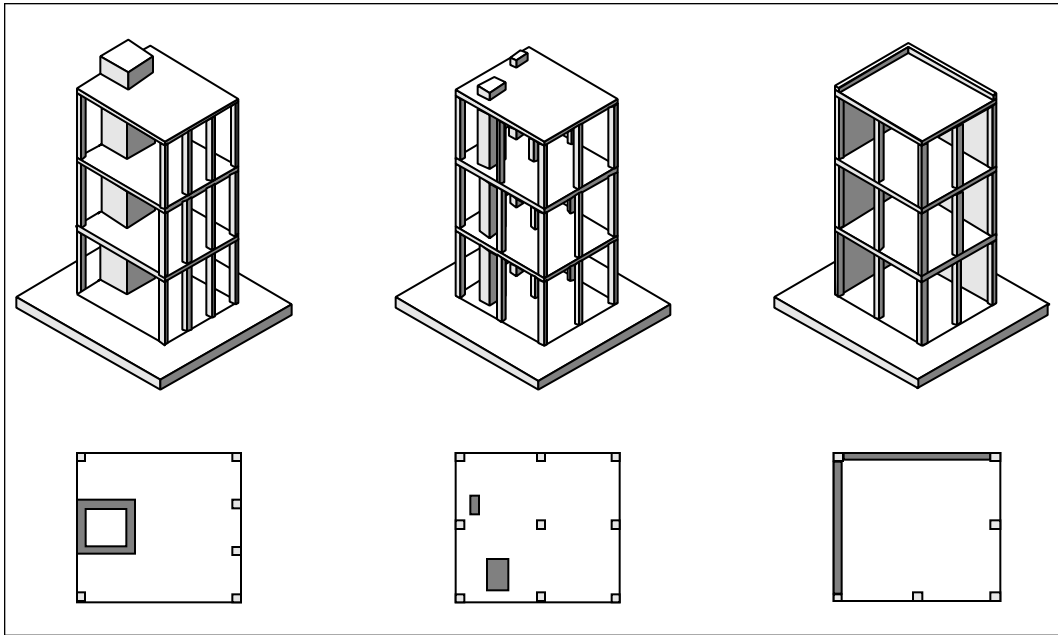
- Torsion should be considered inevitable due to the nature of the seismic event and the characteristics of the structure. For this reason, the suggestion is to provide buildings with so-called perimetric stiffness, which seeks to brace the structure against any possibility of rotation and distribute torsional resistance among several elements.
- In order to control torsion, the layout of the structure in plan and elevation must be studied carefully, as well as the presence and need for isolation of the nonstructural partition walls that could structurally intervene during an earthquake. Finally, the objective of these measures should be to provide to the structure the greatest possible symmetry of stiffness with respect to the mass.

Figure 2.8.
Eccentricity between centers of mass and stiffness increase effects of torsion.

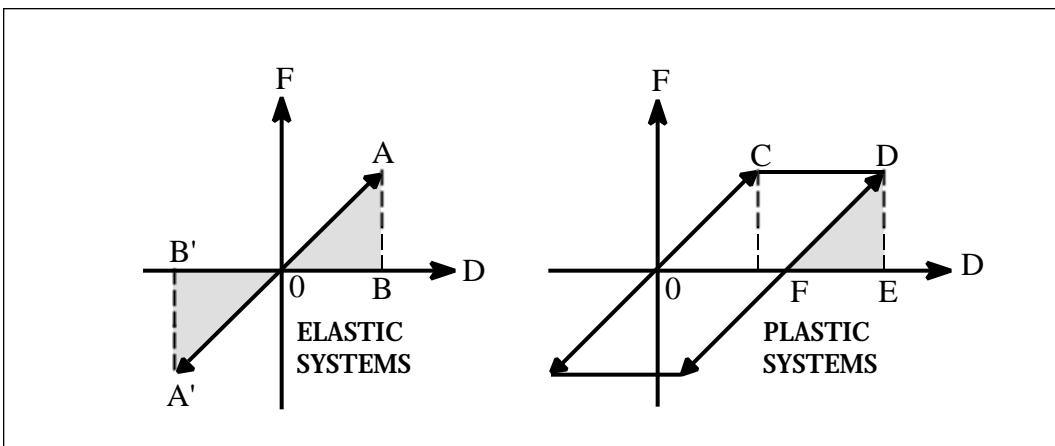
Figure 2.9.
Absorption and dissipation of energy

The criteria for traditional design of buildings subjected to strong earthquakes have been to allow the materials some degree of nonlinear response for the purpose of absorbing energy through permanent deformations. Figure 2.9 illustrates this criterion for an elasto-plastic system. The line OA represents the maximum stress—maximum deformation diagram of a perfectly elastic system during a given earthquake, while the line OCD represents an elasto-plastic system. Several hypotheses exist for the simplification that must be assumed to evaluate the performance of an elasto-plastic system in a simple manner.

The structure must be designed for less stress than is produced by the response of the elastic system. If an elastic analysis is done with the stresses obtained in this manner, some distortions will be obtained that, in turn, must be multiplied by the ductility factor to estimate the maximum deformation of the structure, which is of great importance for the study of the performance of nonstructural elements and the stability of the different floors. The structural elements must then guarantee that these inelastic distortions can be achieved. For this reason, these elements should have sufficient ductility, by means of mechanisms that will be discussed in the next section.

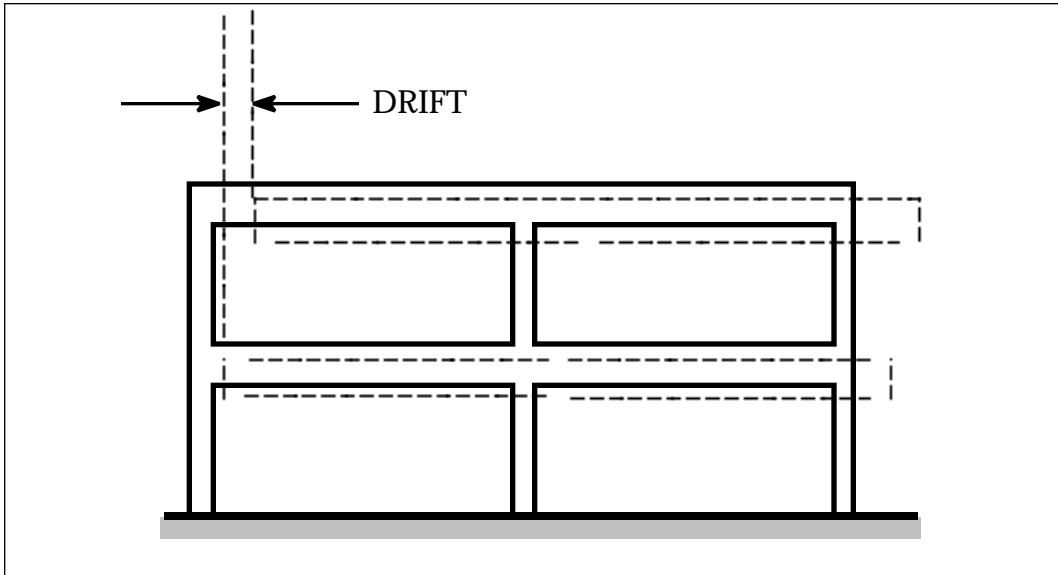
Figure 2.10.
Drift and stability

In principle, large lateral displacements between stories, or "drift", put the entire safety of the building in danger, due to the damage that it can represent to nonstructural elements. Depending on the extent of displacement, partial or total collapse of the building can occur (figure 2.10).

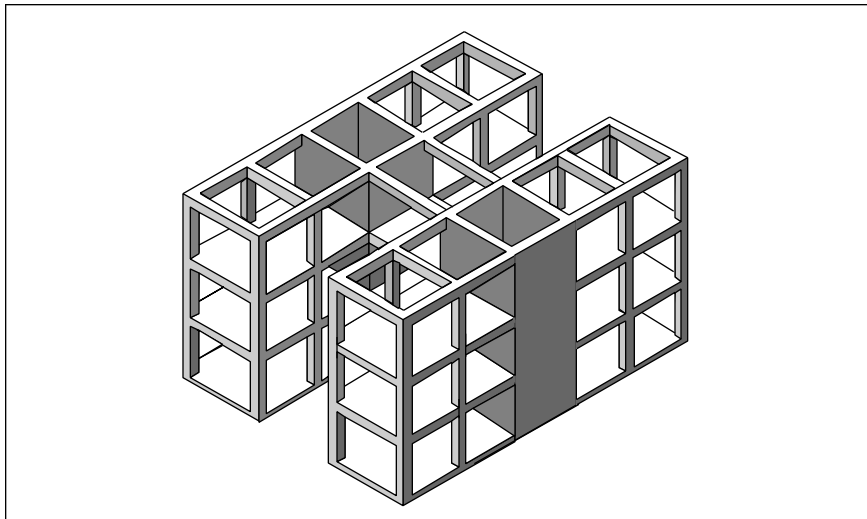
Figure 2.13.
Interior structural walls

When it is possible to work inside a building, these walls are an alternative that should be considered, particularly in long buildings where the flexibility of the diaphragm must be reduced (see figure 2.13). They are generally inserted through perforations in the diaphragm, through which the reinforcement bars pass. This method of retrofitting was used in the National Children’s Hospital of Costa Rica.

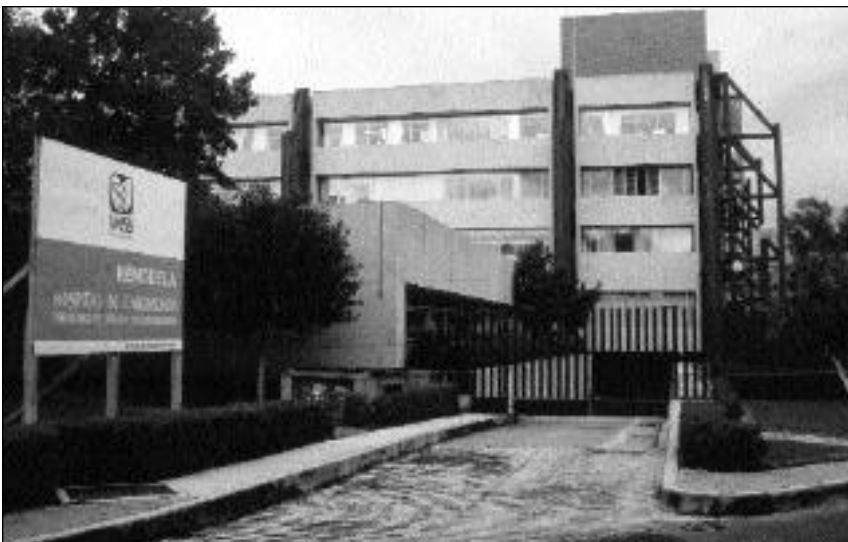
Unlike exterior building walls, buttresses are placed perpendicular to the face of the building. Aside from providing rigidity, they are useful in preventing tall, narrow buildings from overturning. The Cardiology Hospital of the Mexican Social Security Institute (IMMS) uses this type of reinforcement (see pho-

Photograph 12. The Cardiology Hospital of the Mexican Social Security Institute was retrofitted using buttresses following the 1985 Mexico City earthquake.

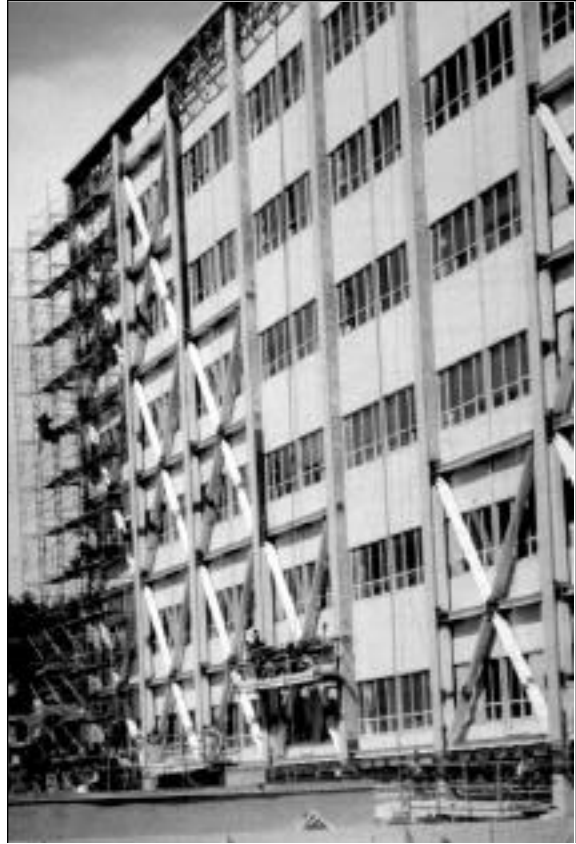
Photograph 13. Reinforcement with diagonals.

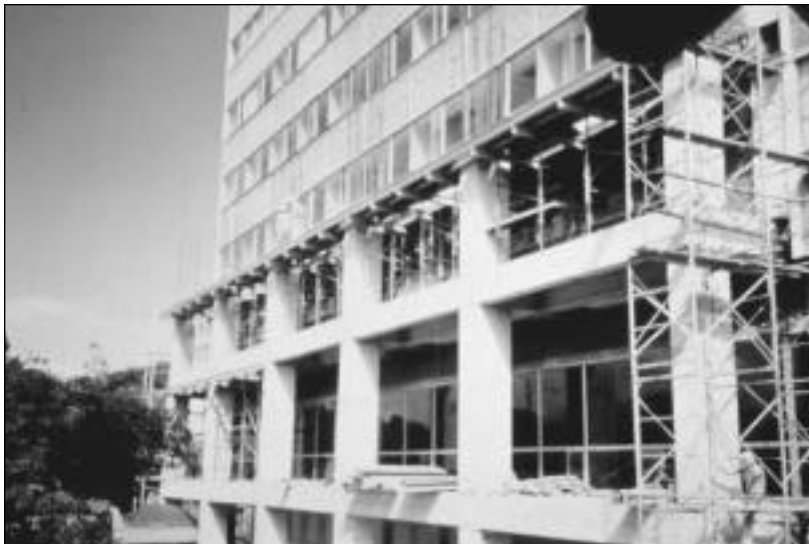
Photograph 14. Use of external perimetric frames for reinforcement of the Hospital Mexico in a project carried out by the Costa Rican Social Security Fund (CCSS).
