# Chapter 3

## Nonstructural Vulnerability

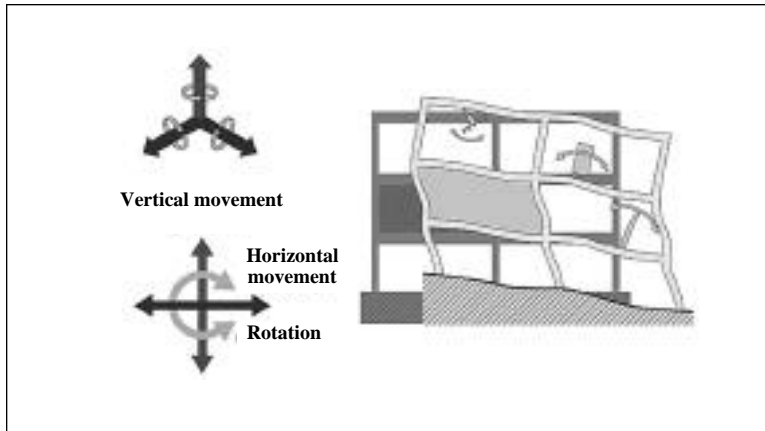
**Figure 3.1.**  
**Response patterns for different sections of building when subjected to seismic forces**

The vulnerability assessment of the nonstructural elements should be carried out after having obtained the results from assessment of structural vulnerability, since the latter is very valuable for judging susceptibility to damage of nonstructural elements. For example, nonstructural elements may be affected by the deformation of the main structure as determined by drift, that is, the relative lateral movement between two stories. Examples in this category would be partitions or other nonstructural elements between floors or placed between structural walls or columns. When there is no direct interaction due to deformation between the nonstructural element and the structural one, the nonstructural element is considered to be sensitive to acceleration. An example would be mechanical equipment located on a certain floor of a building. Equipment placed on higher stories will be subjected to greater forces due to the performance and movement of the structure during seismic vibration. Figure 3.1 illustrates how structures can respond to seismic shaking.

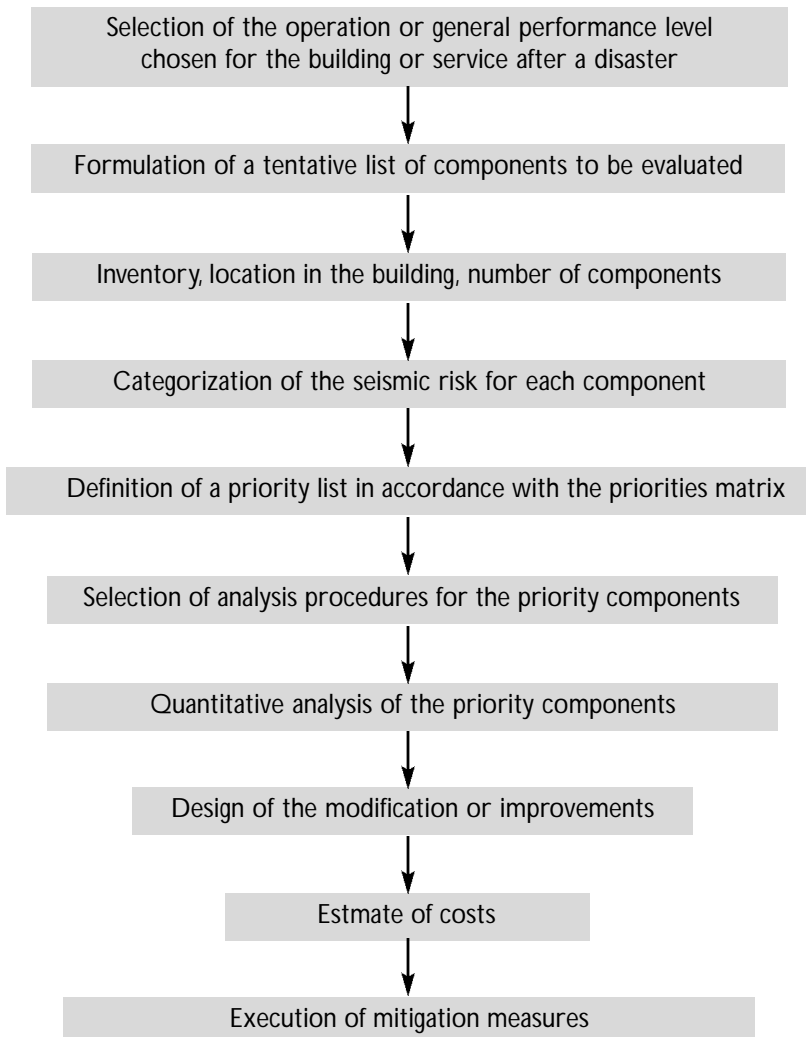
**Figure 3.2.**  
**Steps for conducting vulnerability assessment of nonstructural elements**

Based on these principles, the assessment procedure is established, which basically follows the steps shown in the flow chart shown in Figure 3.2.

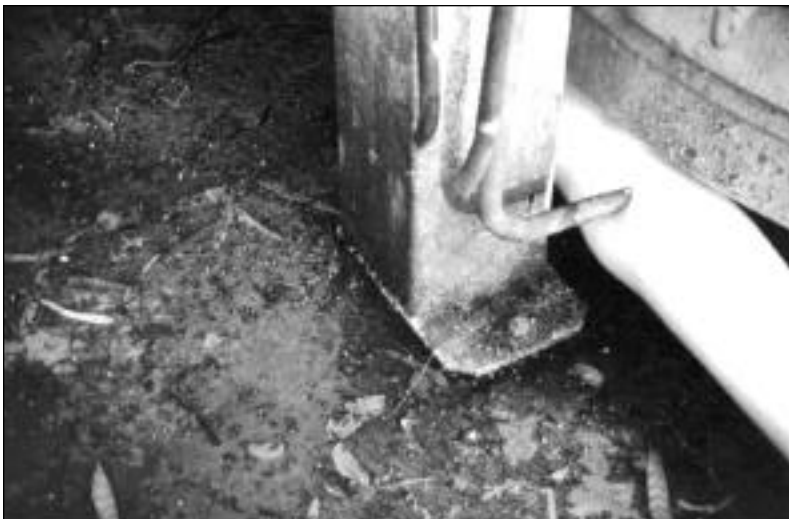
Photograph 16. Detail of support connections for liquid oxygen tank.

An example is shown below of the qualitative analysis of the liquid oxygen tank in a hospital. It is clear from this analysis that in its design the possibility of a strong seismic movement was not considered (table 3.6). Apart from being a slender tank that might easily overturn because its center of gravity is relatively high, its supports are not adequately anchored to avoid the sliding and tipping caused by lateral inertial force (photographs 15 and 16).

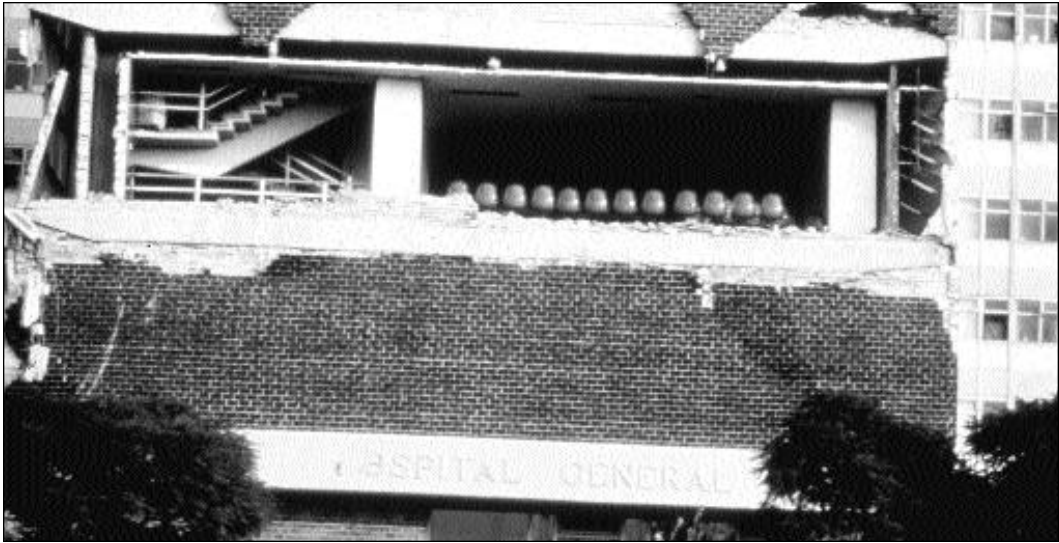
Photograph 17. The addition of aesthetic features on buildings can increase their vulnerability in earthquakes.

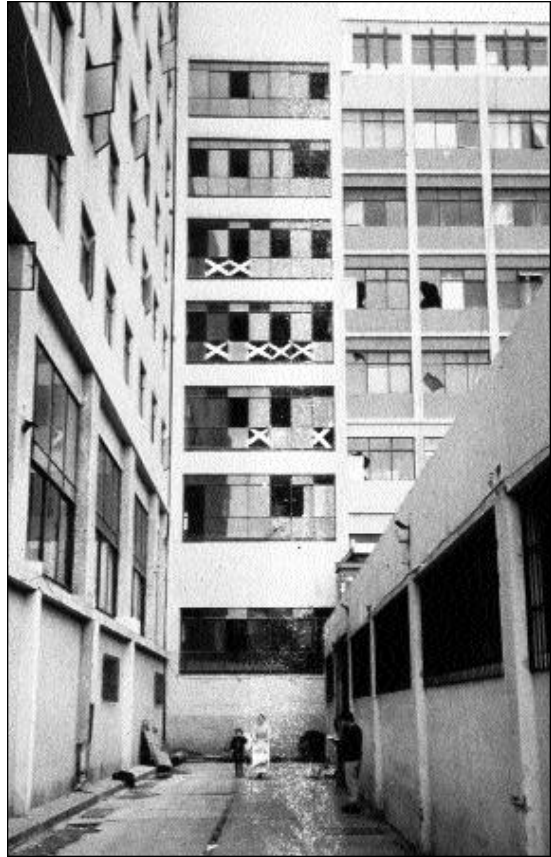
Photograph 20. Broken windows can injure building occupants and obstruct circulation and evacuation routes.

The metal window frames attached to the structure or to the nonstructural walls twist and buckle when they are subjected to large deformations, causing the glass to come out of the frame or to break (see photograph 20). This problem is due to several causes:

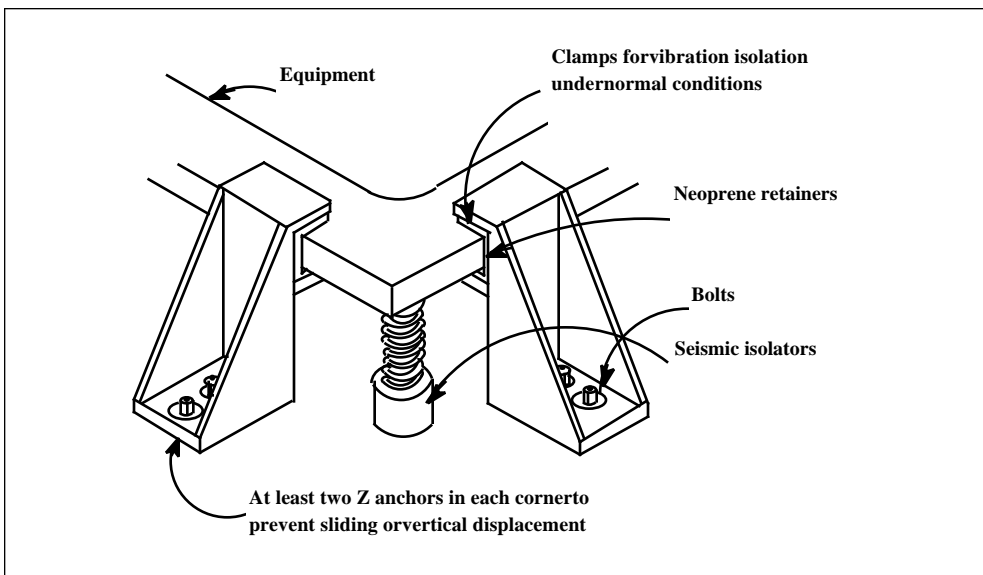
**Figure 3.3.**  
**Vibration isolation clamps**

**Restricted mobility for certain objects** such as gas cylinders and power generators is a good measure. It does not matter if the cylinders shift as long as they do not fall and break their valves. Sometimes back-up power generators are mounted on springs to reduce the noise and vibrations when they are working, but these springs would amplify ground motion. Therefore, restraining supports or chains should be placed around the springs to keep the generator from shifting or being knocked off its stand (see figure 3.3).

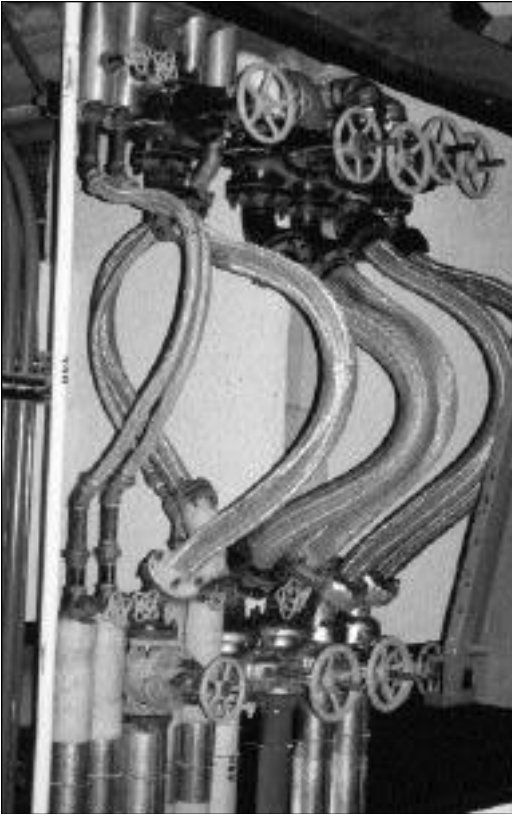
Photograph 21. The use of flexible piping in critical areas such as between buildings and equipment helps to prevent breakage

**Flexible couplings** sometimes are used between buildings and outside tanks, between separate parts of the same building, and between buildings (see photographs 21 and 22). They are used because the separate objects each move independently in response to an earthquake: some move quickly, others slowly. If there is a tank outside the building with a rigid connection pipe that joins them together, the tank will vibrate at frequencies, directions and amplitudes that are different to those of the building, causing the pipe to break. A flexible pipe between the two would prevent ruptures of this kind (see figure 3.4) .

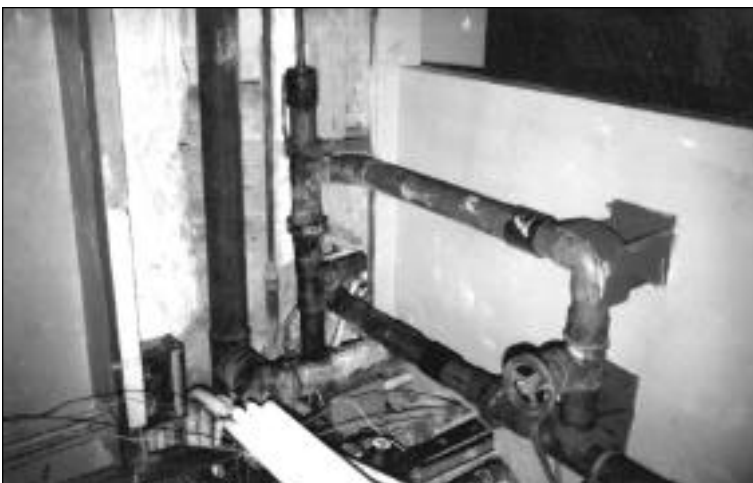
Photograph 22. Rigid piping

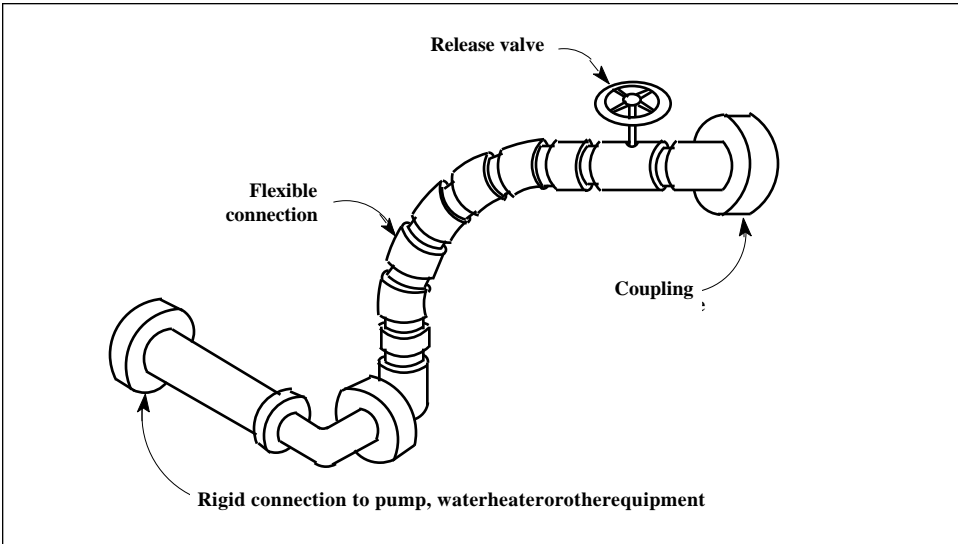
**Figure 3.4.**  
**Flexible fitting and connection**

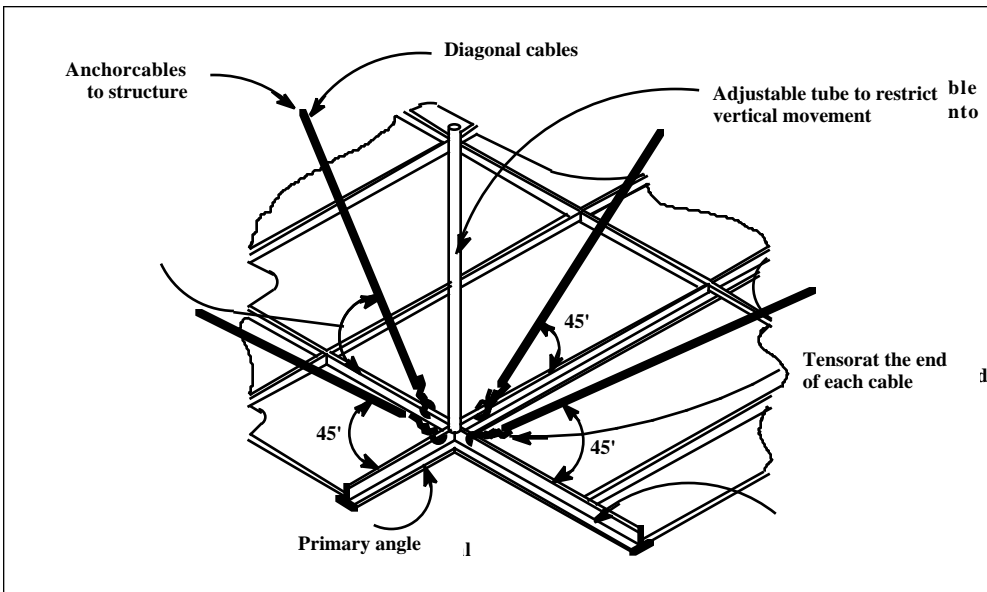
**Figure 3.5.**  
**Supports for ceiling**

**Supports** are suitable in many cases. For example, ceilings are usually hung from cables that only withstand the force of gravity. When subjecting them to the horizontal stresses and torsion of an earthquake, they easily fall (figure 3.5). They can cause serious injury to the people who are underneath them and obstruct evacuation routes.

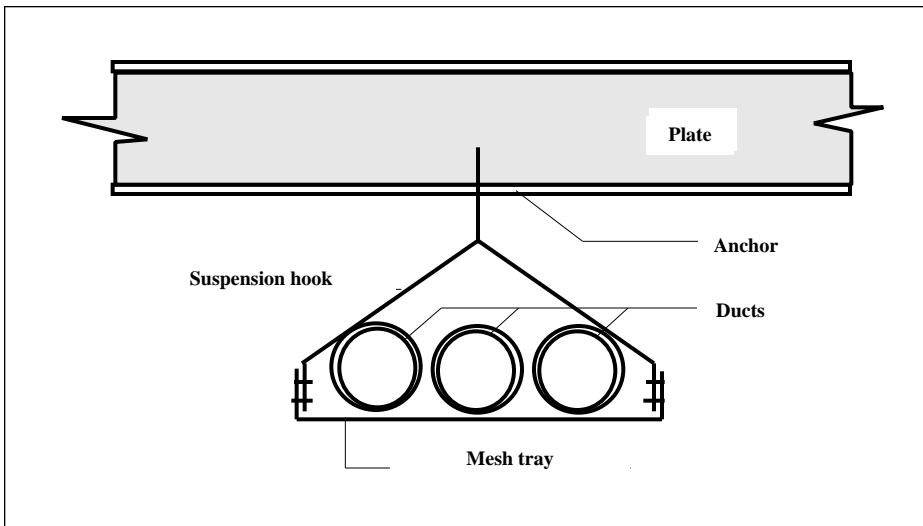
**Figure 3.6.**  
Detail of the hanging duct

The same solution should be applied to vertical ducts, which, if properly located with sufficient space, can absorb seismic movements. It is also important to provide for doors in these ducts to allow access for inspections and maintenance to the system (see figure 3.6).

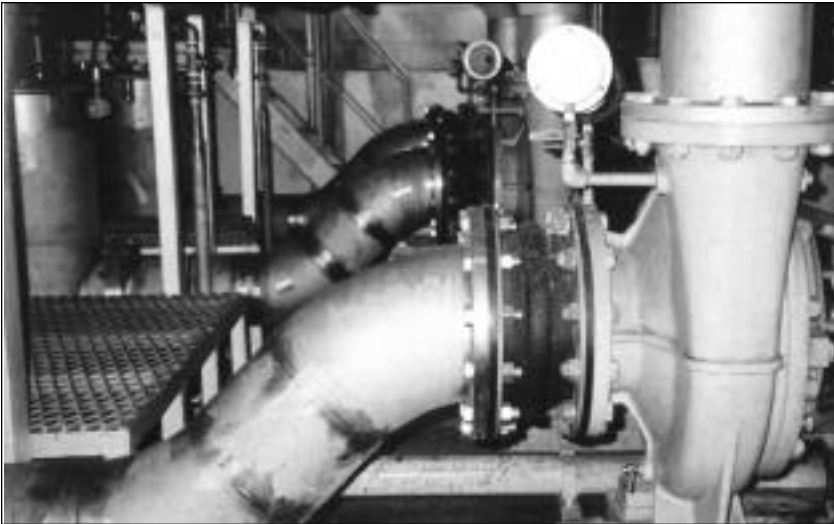
Photograph 23. Piping with flexible connections
