Smart put to the test: Practical lessons learned

How Smart healthcare facilities withstood the test of the La Soufriere volcanic eruption in Saint Vincent and the Grenadines in April 2021 and the passage of Category 5 Hurricane Beryl in July 2024.

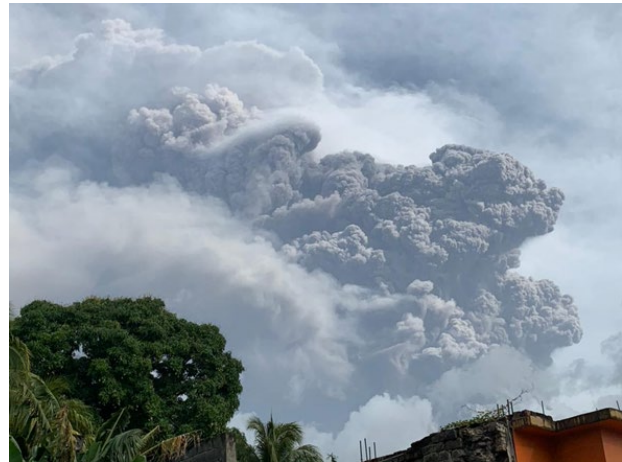
The eruption of La Soufriere volcano on the main island of Saint Vincent (Saint Vincent and the Grenadines) occurred on 9 April 2021 after several months of increased seismic activity. Volcanic emissions (ash and gas) impacted basic services (water, transport, and communications) and access to health services, as 18 healthcare facilities (including 2 district hospitals and 1 dialysis centre) were evacuated. The ash fallout also severely impacted Barbados and Saint Lucia.

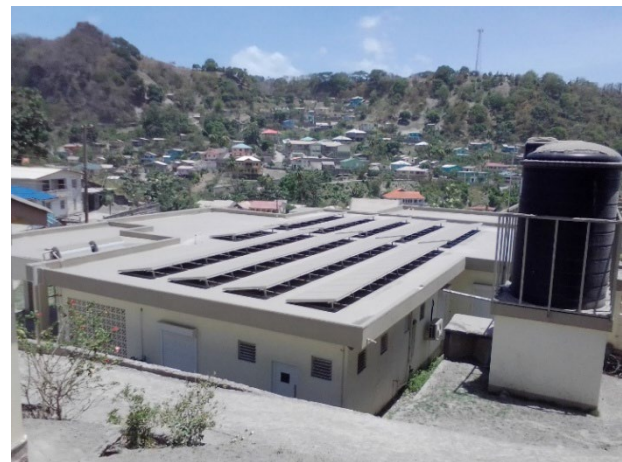
The eruption of La Soufriere underscored the importance of the Smart Hospitals project. The Smart healthcare facilities in Georgetown, Chateaubelair (see picture), and Barrouallie (still under construction during the eruption) sustained minimal damage. Most of the ash could not enter the facilities, roofs were intact, and the available water from the water storage was used by the communities. Other healthcare facilities did suffer substantially more damage, including damage to medical equipment, and took much longer to clean and to continue provision of health services to the public.

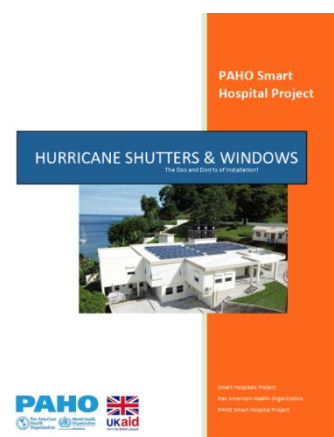
Key Things to Check

Quantify and measure existing dimensions before purchase

Doors and windows with a transom or side lights are fully covered with the shutter

Check that existing walls and structure meet manufacturers' specifications

Retrofit the existing structure by strengthening walls and removing encroachments where necessary

Install the correct components, including storm bars, per manufacturers specifications

Use correct screws, tools and spacing per manufacturers specifications

Operating levers, handles or locks should be accessible and functional

Ensure shutters and windows can fully open and close without difficulty

In [Hurricane shutters & windows: The dos and don'ts of installation](#) (4), contractors retrofitting healthcare facilities in the Caribbean are recommended to purchase and install hurricane-rated windows or shutters that are certified with a Notice of Acceptance (NOA) to Miami-Dade Building Code. Miami-Dade, which is an addition to the Florida Building Code for hurricane-prone zones, uses wind speeds in the testing of windows and shutters that are comparable to the wind speeds experienced in the Caribbean. The Florida Building Code uses a classification of high-velocity hurricane zones for areas vulnerable to hurricanes.

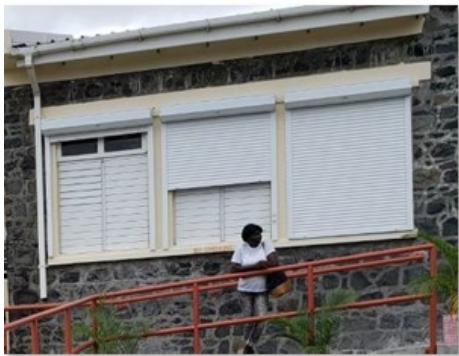
Final look

Roller shutters covering the windows and transoms at Princess Alice Hospital, Grenada.

Shutters in various stages of open and fully closed

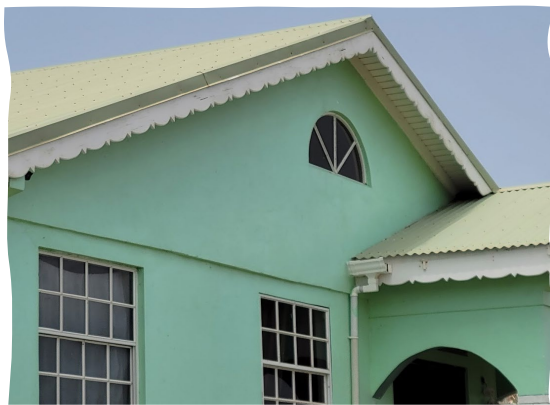
Roof Sheets

- Use specified grade lumber of good quality (free of knots, splits, etc.)
- Use correct gauge/ thickness and type of metal roof sheets
- Increase fasteners in high-pressure roof zones
- Use roofing screws with compressible gasket
- Connect the screws properly
- Install screws in crest not trough
